Geocomp Corporation  
Supplemental Analysis  
And  
Comment Response

8 May 2007  
Jon No. 20113

Subject: MSE Perimeter Berm  
Crow Lane Landfill Corrective Action  
Design - Newburyport, Massachusetts

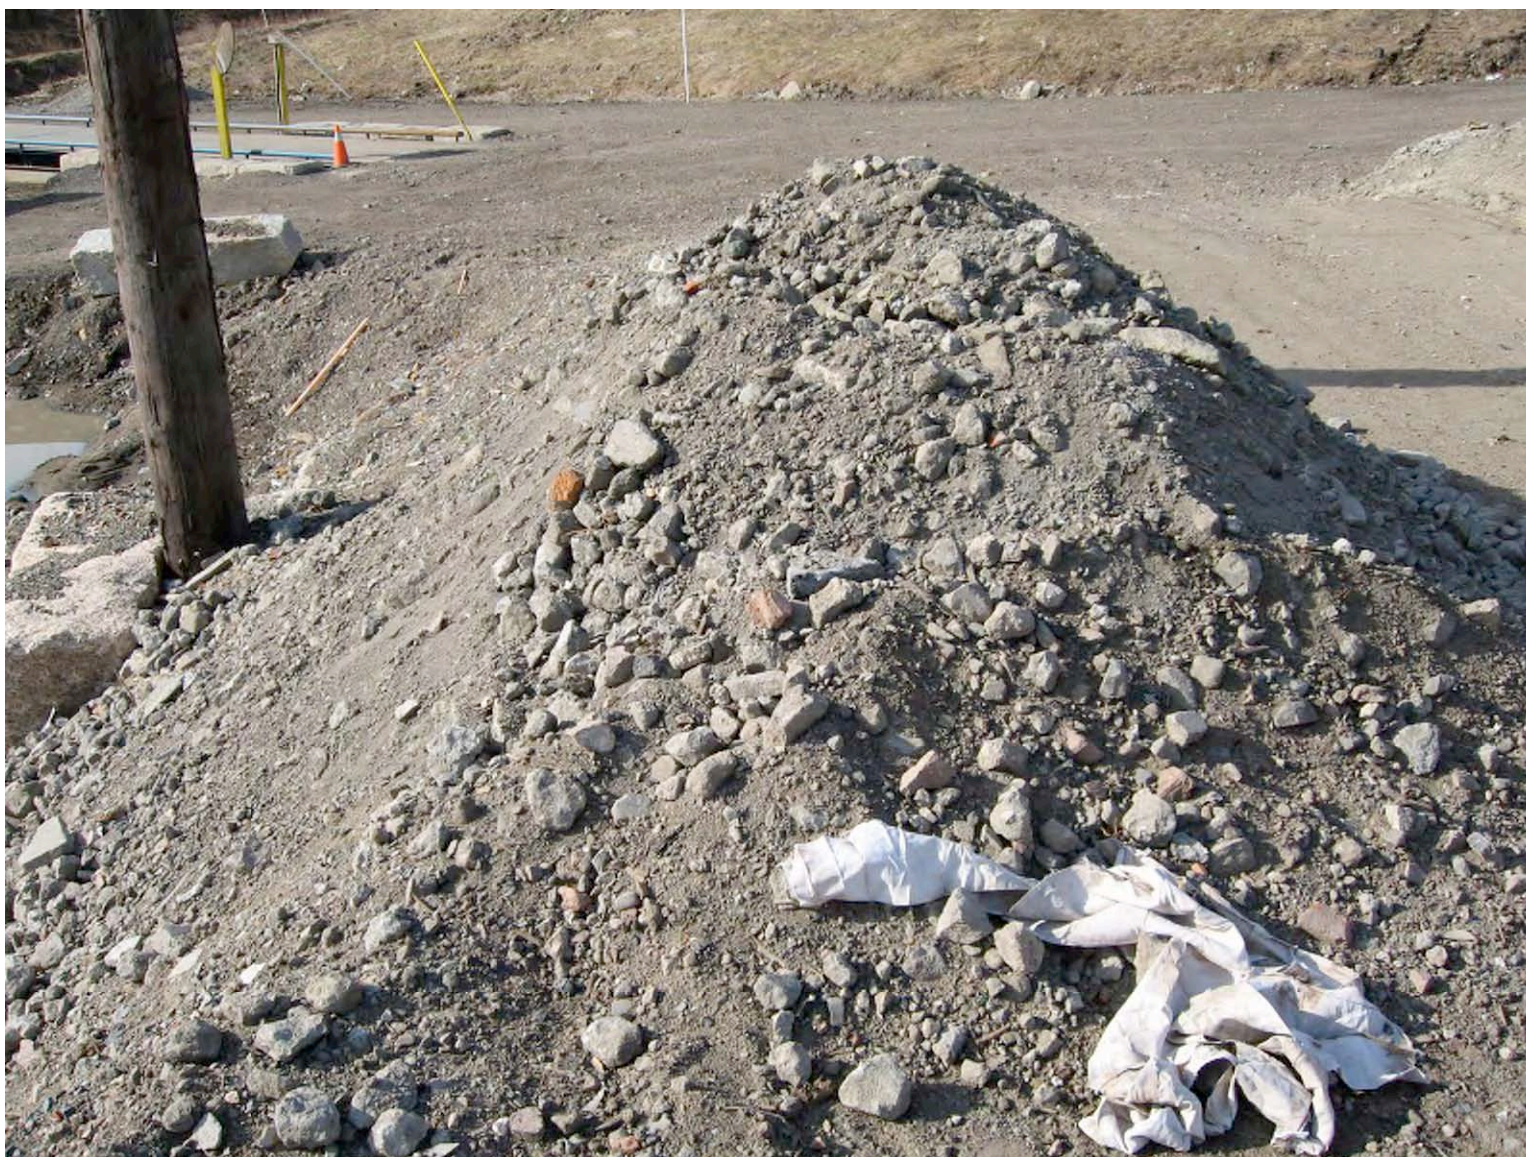
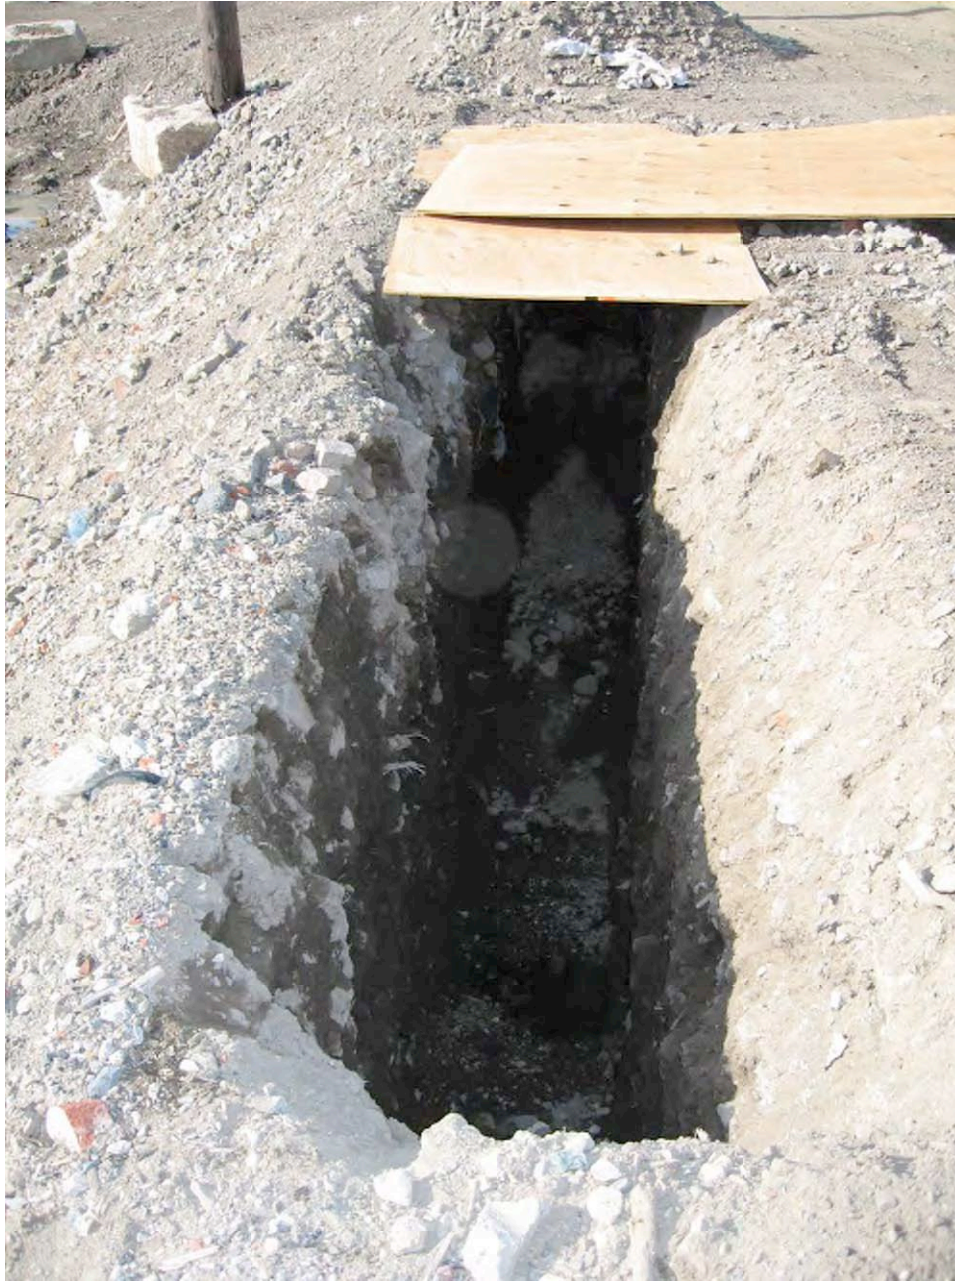
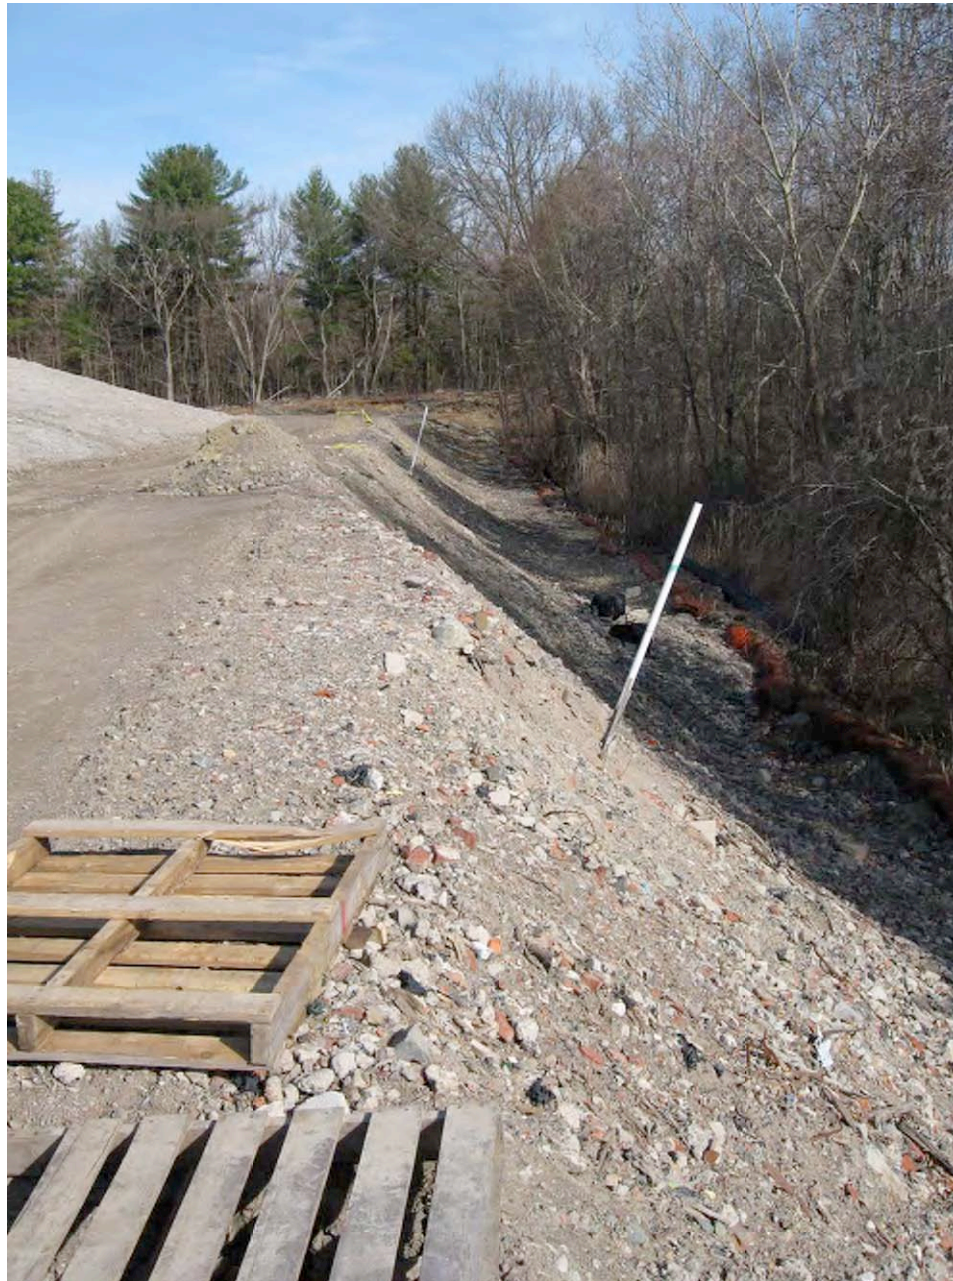
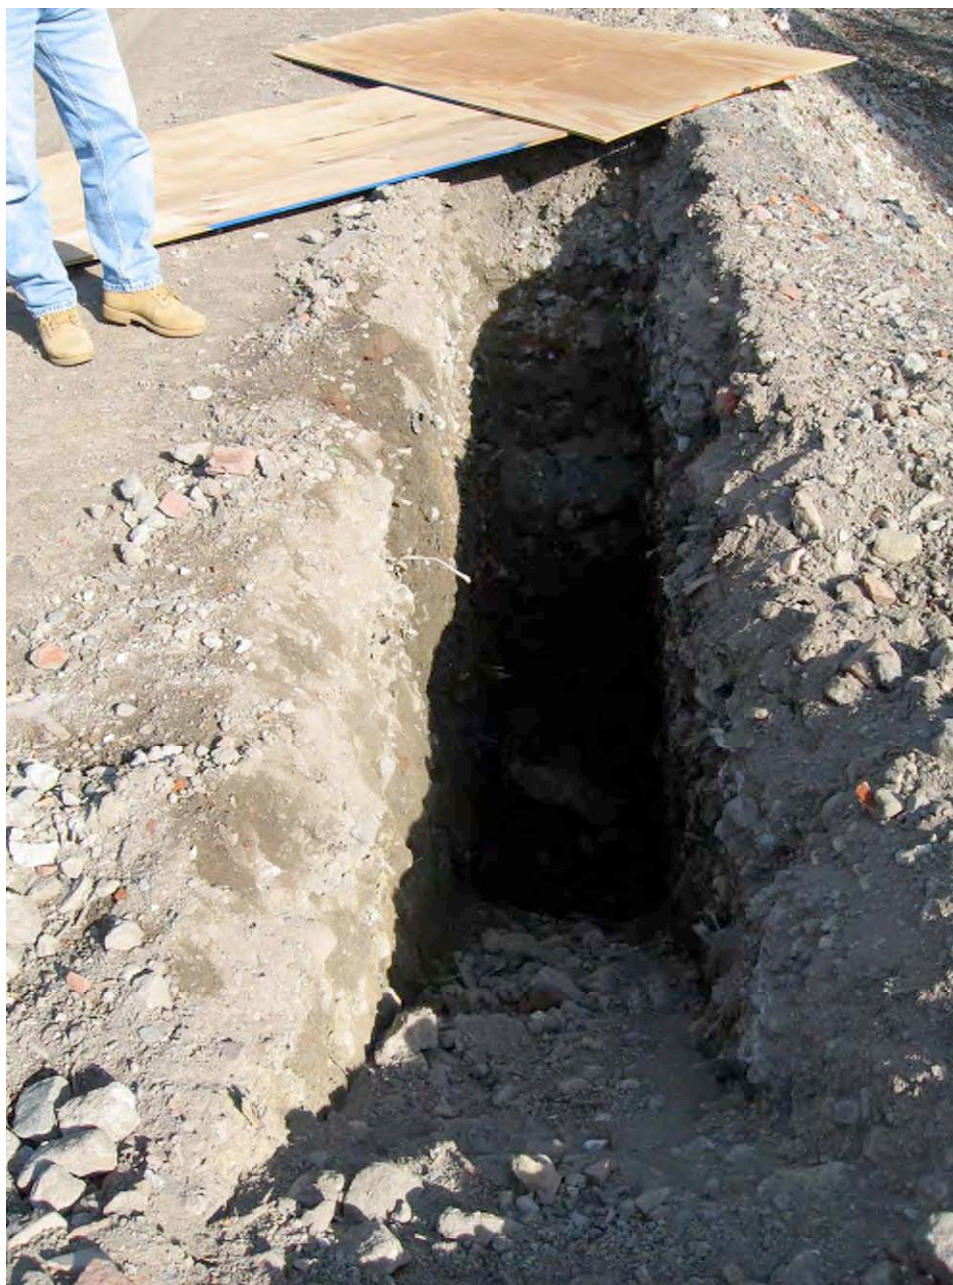
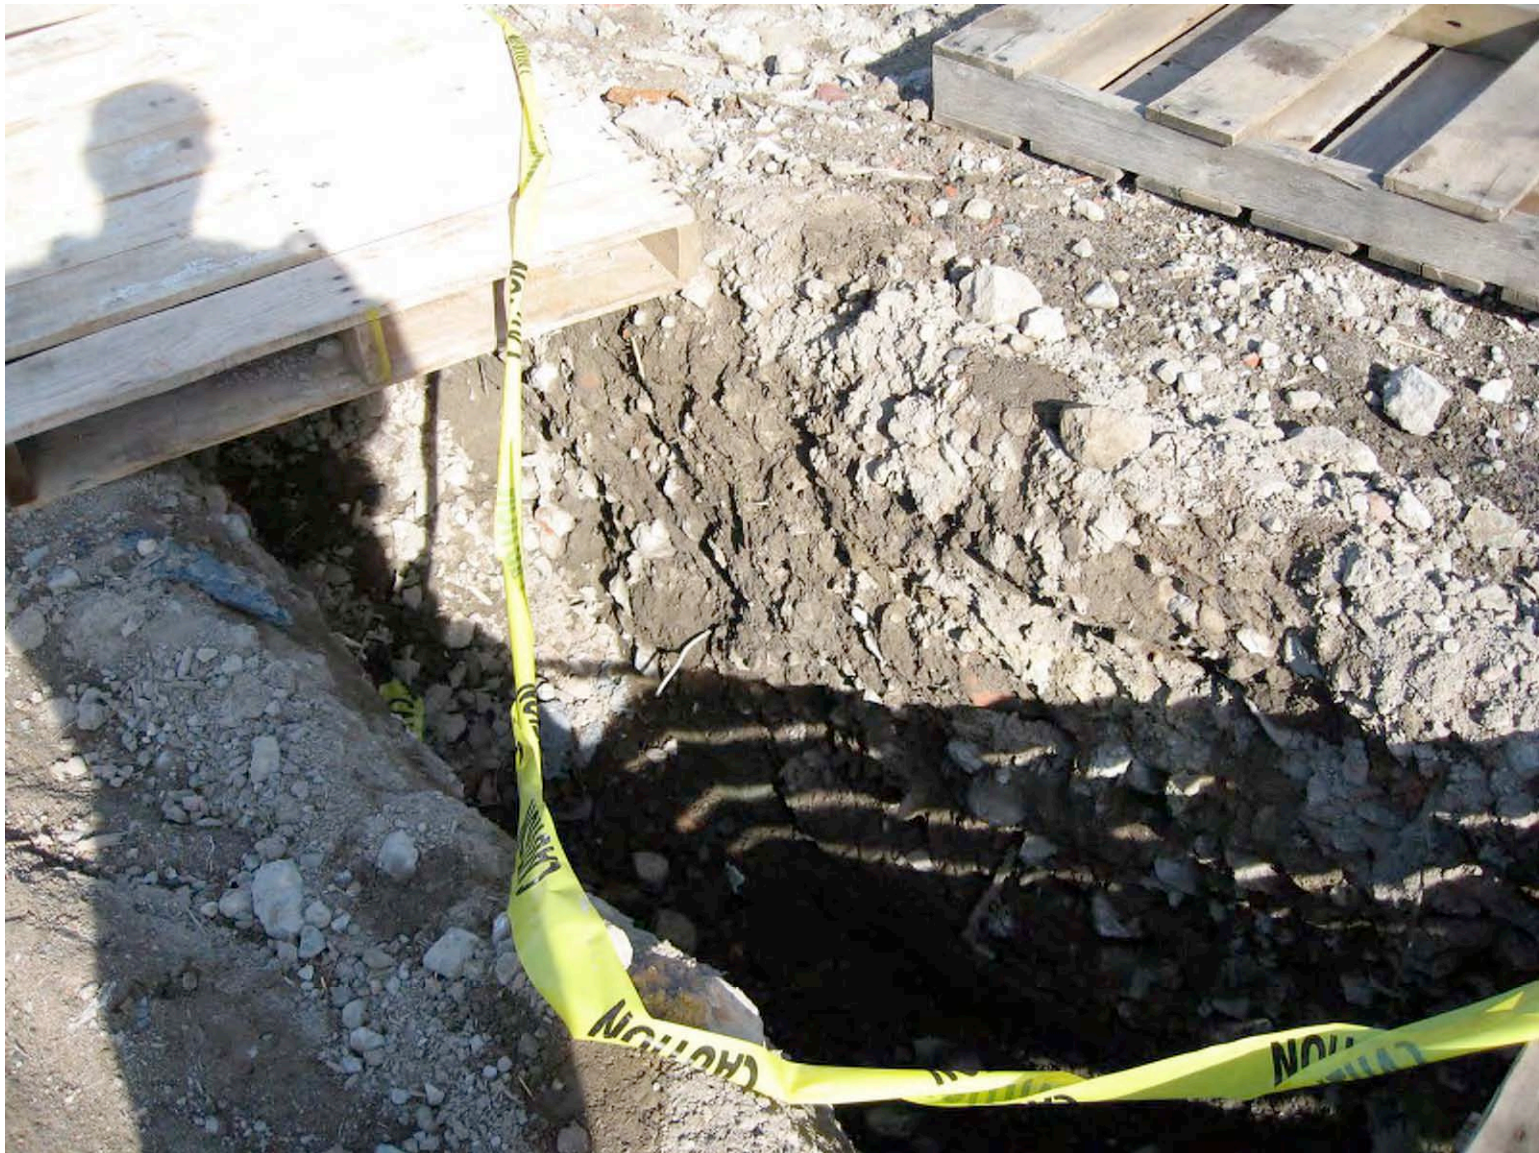
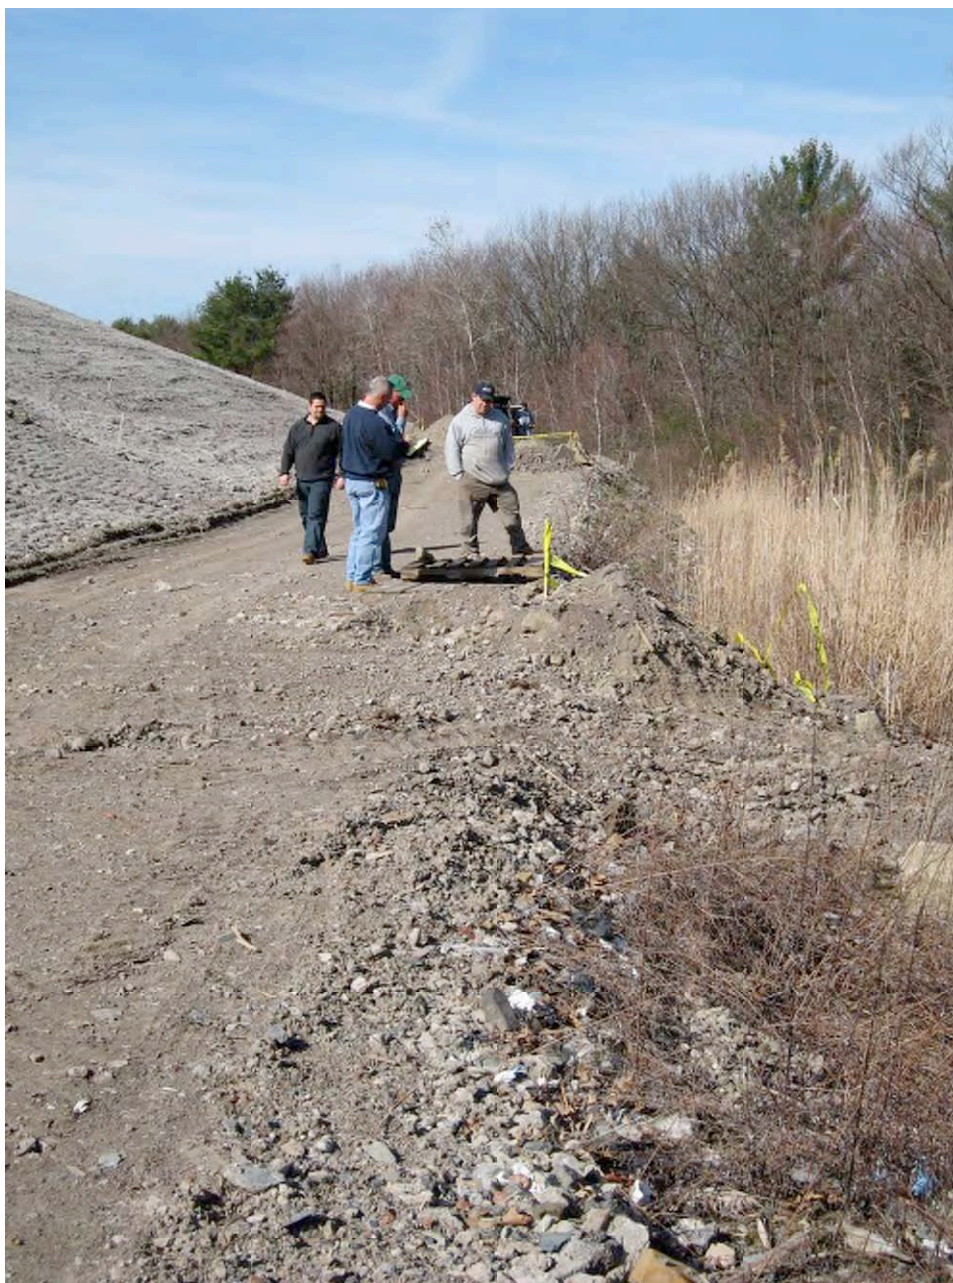
Test pit pictures 04/03/06

- a. On 3 April, 2006 Mr. Dick Stulgis (GEOCOMP Corporation) visited the site and observed conditions in 18 machine-excavated test pits that had been performed through the top of the berm around the perimeter of the landfill by New Venture Associates. The test pits ranged from several feet to in excess of 8 ft. deep. Generally, processed asphalt, brick and concrete materials, with varying amount of fines, was observed in the test pits (see attached Photographs). Samples were collected and delivered to GEOCOMP Corporation. The sampler collected the soil-size fractions of materials without the larger pieces.

With the exception of sample P 16-3, which is 95% gravel, the samples appeared consistent and typically comprised of a brown silty gravel with sand, AASHTO Classification A-1-a Stone fragments, Gravel and Sand with larger pieces of crushed concrete, bricks and stones.
